# Manhole Inspection Summary

Manhole # S13GG2023MH

**Location** Address: **6102 IVYDENE TRAIL**

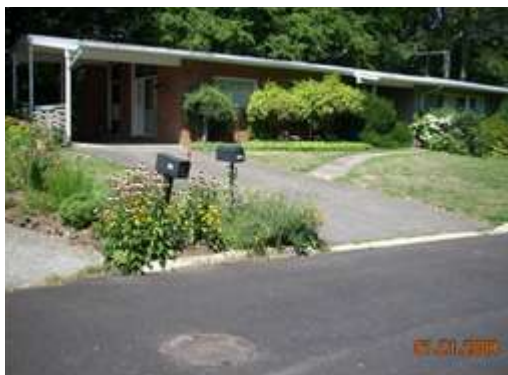
Location View

Comments **Cracks in pavement around manhole. Possible source of infiltration. The I6 pipe seal is not flush to the pipe.**

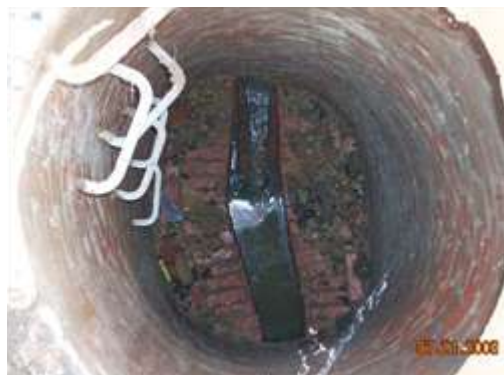
Top View

Corroded steps. Evidence of surcharge - Bench debris. Channel debris.

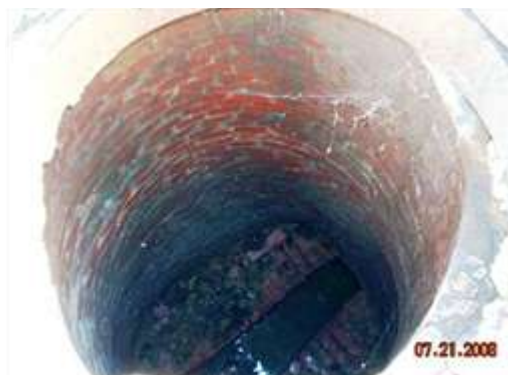
Defect

Frame leaks. Frame offset. Adjustment deterioration, loose brick and infiltration. Corbel and Barrel infiltration - other side.

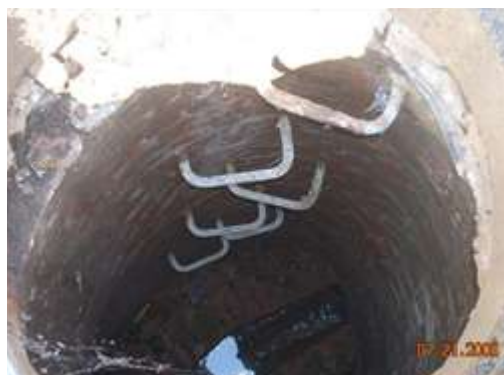
Defect

Frame leaks. Frame offset. Adjustment deterioration, loose brick and infiltration. Corbel and Barrel infiltration.

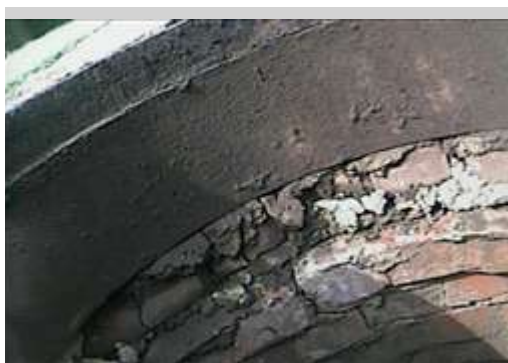
Defect

Frame leaks. Adjustment deterioration and infiltration.

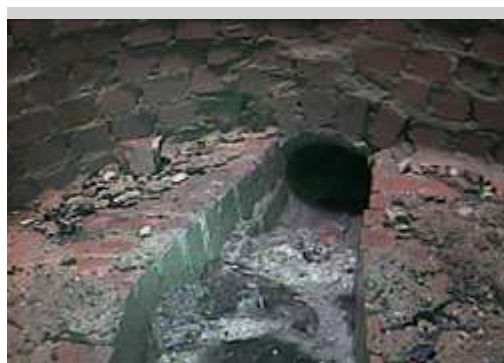
Defect

Barrel deterioration and infiltration. Channel debris.

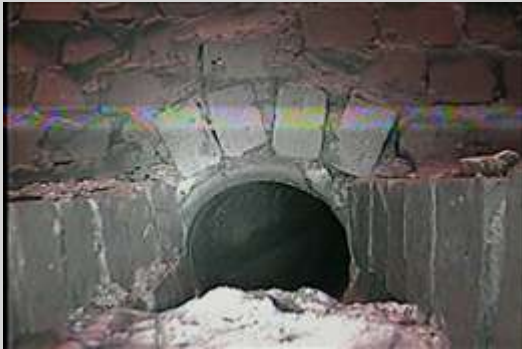
### 8 in. Circular Gravity Sewer Pipe Out @ 12 O'Clock

Deposits: ☐ None ☐ **Mud** ☐ Sludge ☒ **Debris** ☒ **Grease**

Infiltration: **None** Pipe Seal Cond: **Cracked**

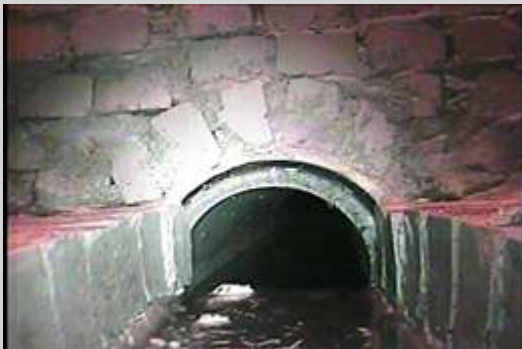
### 8 in. Circular Gravity Sewer Pipe In @ 6 O'Clock

Channel deterioration.

Deposits: ☐ None ☒ **Mud** ☐ Sludge ☒ **Debris** ☐ Grease

Infiltration: **Evidence** Pipe Seal Cond: **Unknown**
